The Safety Institute

We are writing to put into the record our concerns about the conclusions expressed in *Inspection and Assessment of Crash Test Protocols: Task 3.1-Task 3.2 Report – Part II (31” ET-Plus System Crash Tests)*. Our examination of the visual record and the methodology used to assess injury potential, in concert with the requirements of the NCHRP Report 350 lead us to a very different assessment of Test 31-30.

Test 31-30 is clearly a FAIL.

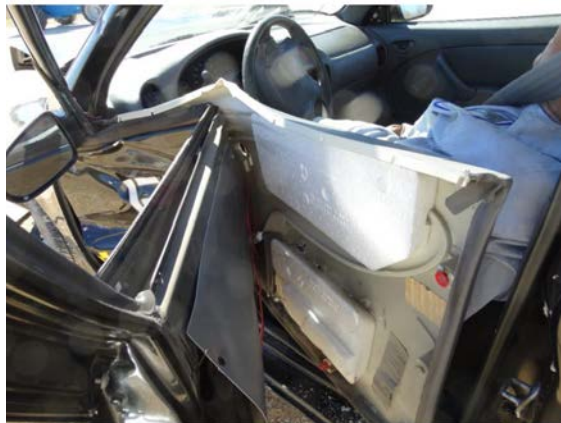
Figure 3.70: Post Test Vehicle – Left Side Door Panel ⁵

The video record shows that the ET-Plus energy-absorbing end terminal did not permit the rail to fully extrude, and allowed it to fold into a spear, causing at least 6.75 inches of post-crash intrusion into the vehicle. We note that the measurement was taken with the door *open*, which, of course, will result in a smaller intrusion measurement (see Figures 3.70 and 3.82 below).

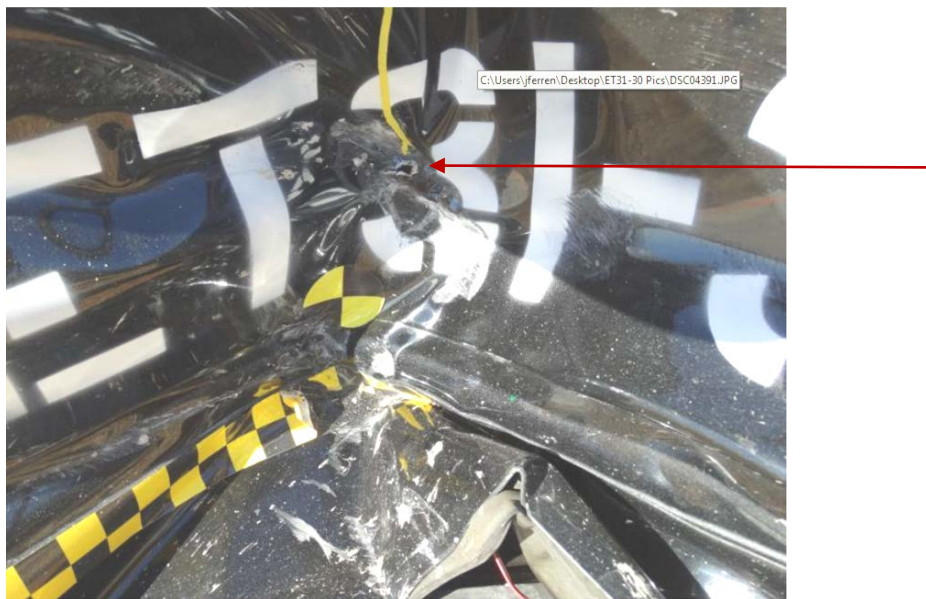
Figure 3.67: Post Test Vehicle – Left Side Door, Close-up

Photographs of the deformed door shows the presence of holes in the exterior of the door, documenting *guardrail penetration* through the outside metal surface of the driver's door (Figure 3.67)⁷

First, Test 31-30 clearly showed penetration into the occupant compartment space – 6.75 static inches in the leg area, and much greater dynamic intrusion – there and elsewhere in the driver's occupant compartment. There was also evidence of penetration – yet, Dr. Clay Gabler avoids addressing the essential test criterion - which serves to protect vehicle occupants from failures like the one seen in this test. Instead of evaluating the potential penetration of the driver's door by the folded guardrail, he refers to the holes in the door, apparently caused by contact with guardrail, as "tearing" rather than penetration.

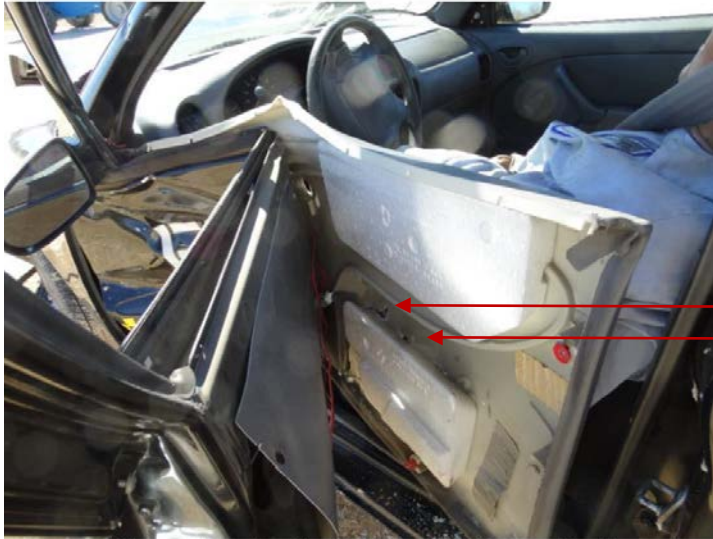
Figure 3.70: Post Test Vehicle – Left Side Door Panel

There are also holes in the outboard side of the interior door panel that are potentially from intruding guardrail penetration or flying guardrail debris. (Figure 3.70).⁸ These have corresponding holes/tears in the plastic in the inboard side of the door panel. (Figures 3.82; 3.83)⁹ This is also in the area of the deformed seat pan and driver dummy's leg, which has tears in the pants cloth (Figure 3.72).¹⁰

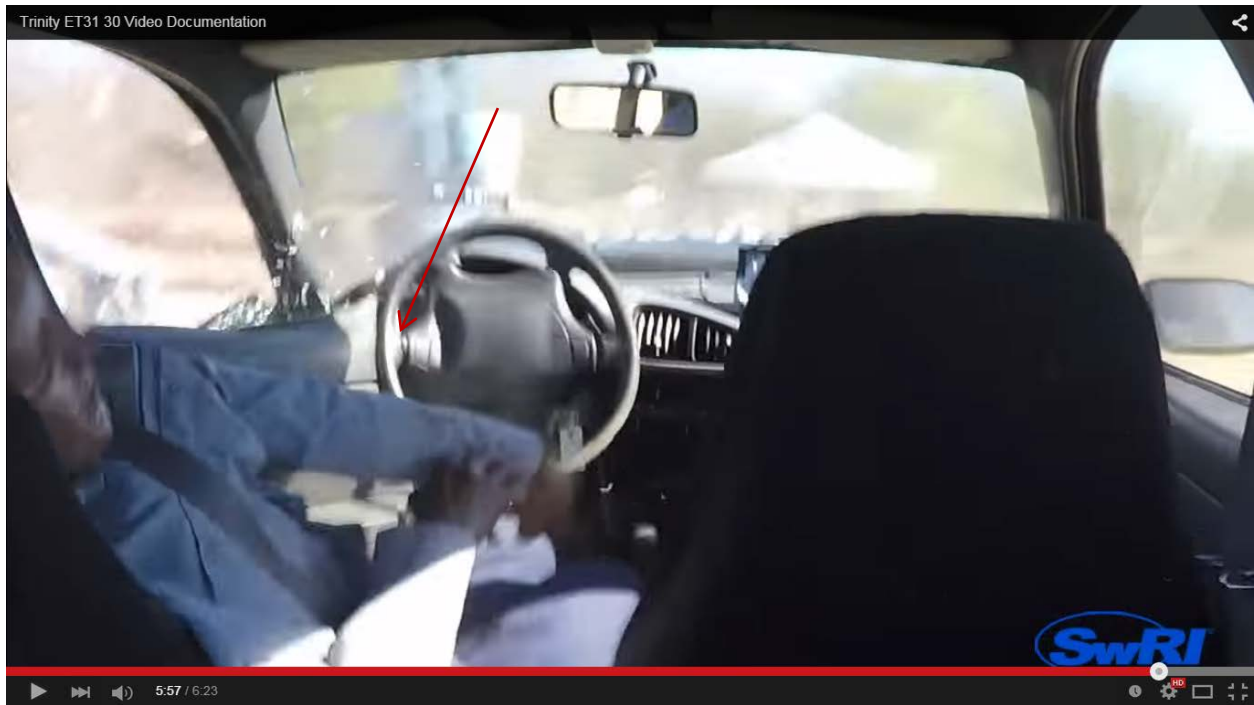
The [crash test video](#) documents that the dynamic deformation in the test vehicle is significantly more than the static deformation. The extent of the dynamic deformation can be seen at times 5:09 and 5:57 in the test video (see still images below). It is clear that the dynamic deformation causes the interior door to intrude much further into the occupant compartment, even deforming the steering wheel, and then recoil to the post-crash deformation of 6.75 inches of intrusion. Dr. Gabler affirms this when he notes that the intrusion deforms the steering wheel.^{11 12}
